Pneumatic Piston Vibrator

Vibrators as Material Flow Aids vs. Costly UHMW Liners

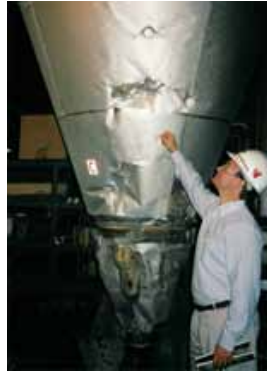
Hammer damage to hoppers impairs flow.

A steel mill in Baltimore, Maryland was experiencing flow problems with their alloy feed bunkers. The material would often rathole near the outlet opening, slowing production. Crowbars or sledgehammers were used on the bunkers to keep the material moving. Eventually, damage from hammers reduced the materials' ability to slide along the hopper wall, further aggravating flow problems.

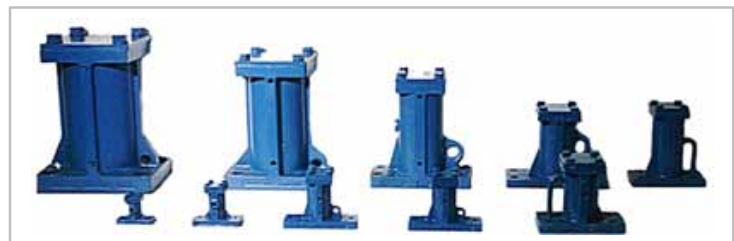
After running non-stop for 7 hours, using no lubrication, against 6 similar competitor vibrators, NAVCO®'s BH was one of only two vibrators that were still running smoothly and upon inspection there was no evidence of wear on the piston or bore of the BH.

Available in 10 sizes, the BH fits any application, and BH Vibrators are available with Teflon Coating for longer life and less wear in harsh conditions.
